State of Nevada  
Department of Corrections  
Ely Conservation Camp  
Facility Condition Analysis

# ELY CONSERVATION CAMP

**Site Number: 9976**

**STATE OF NEVADA PUBLIC WORKS BOARD  
FACILITY CONDITION ANALYSIS**

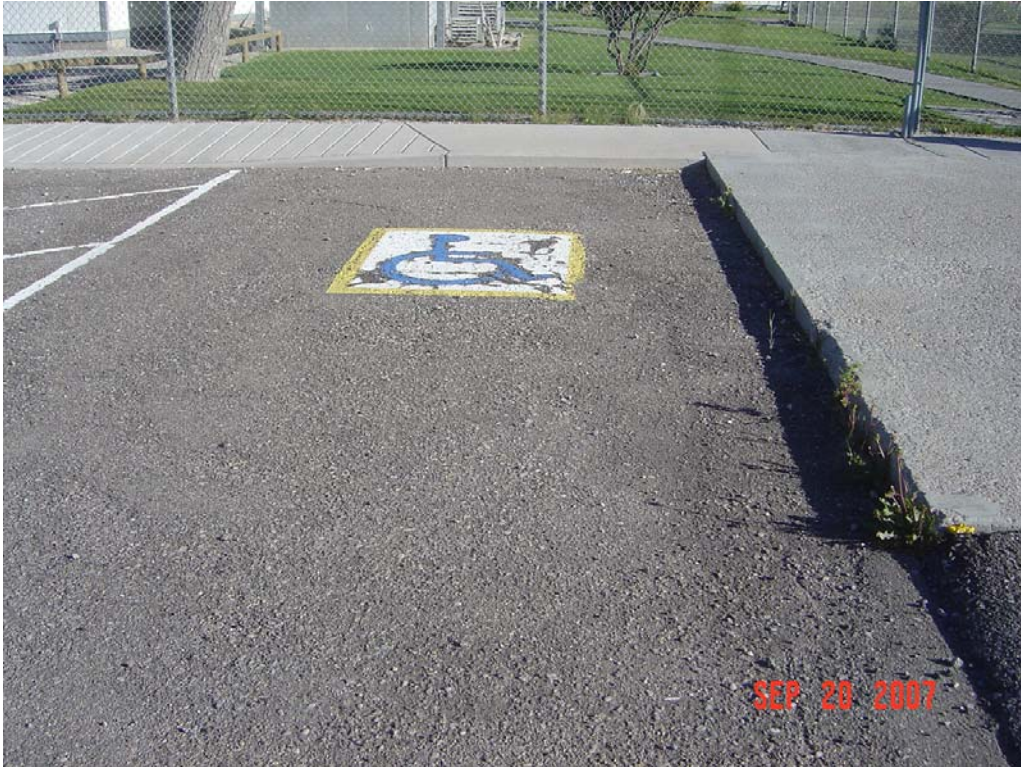
Ely Conservation Camp - Site #9976  
Description: ADA accessible parking stall.

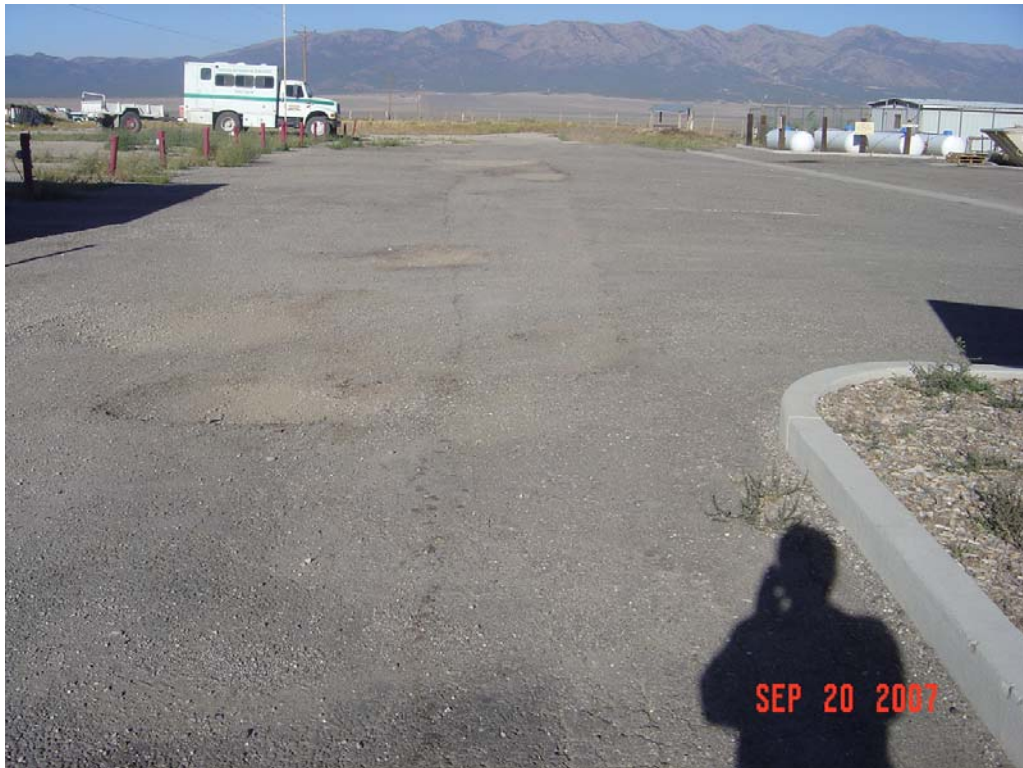
Ely Conservation Camp - Site #9976  
Description: Parking area.

It is important to maintain the asphalt concrete paving on the site. This project would provide for patching, minor crack filling and slurry sealing of the paving site wide including loading zones, access roads and parking areas. Striping is included in this estimate. This project should be scheduled on a 5 year cyclical basis to maintain the integrity of the paving and prevent premature failure. This project should coincide with the ADA parking project.

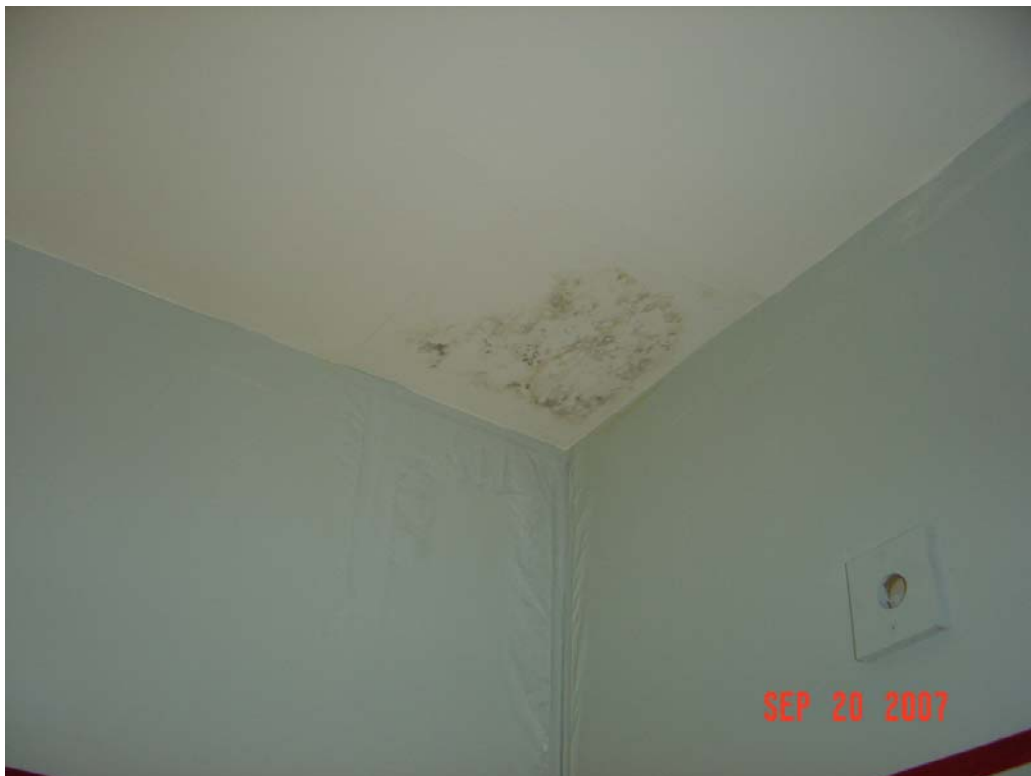
Multi-Purpose / Gymnasium - Building #1389  
Description: Water damaged ceiling.

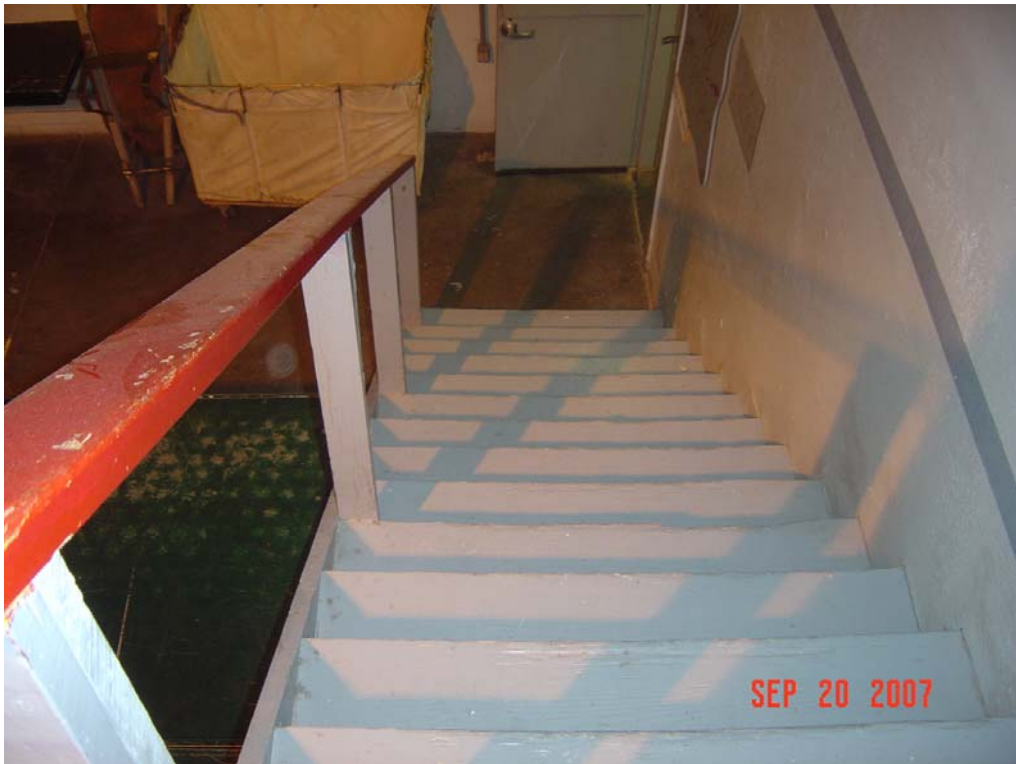
The handrails and guardrails at the stairway and storage mezzanine do not meet the building code requirements in their current configuration. This project would provide for the removal of the existing wood framed railing and replacement with new wood framed handrails and guardrail that will meet the 2006 IBC code Chapter 10, Section 1012 and 1013.

Multi-Purpose / Gymnasium - Building #1389  
Description: Interior stairway.

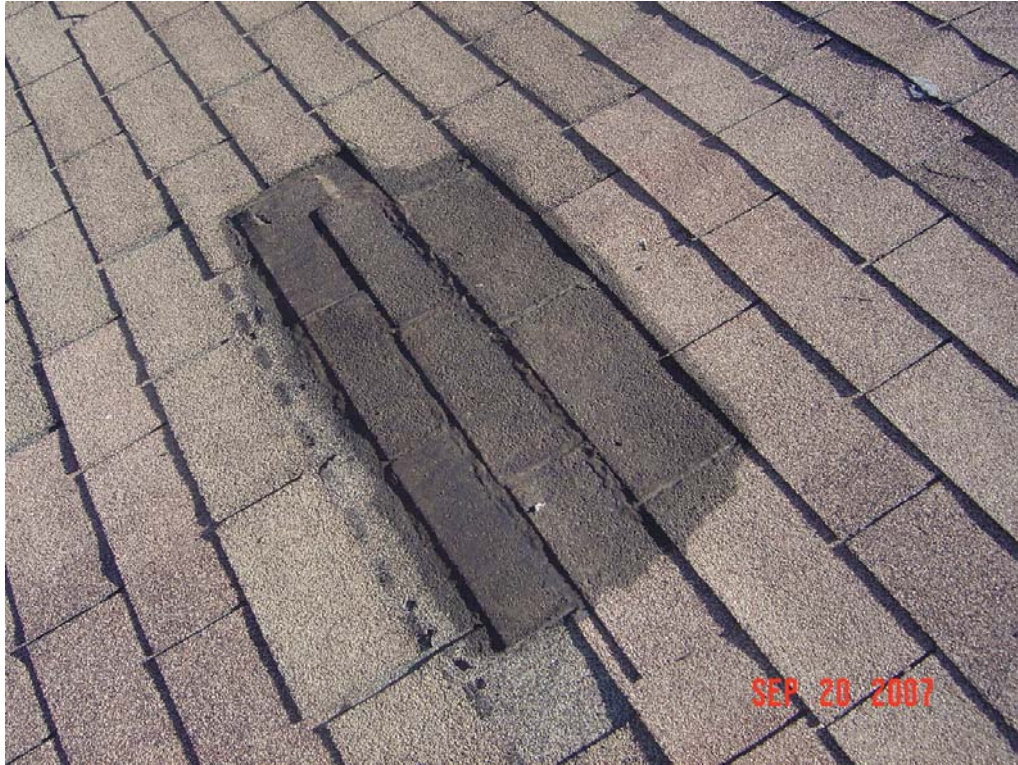
The asphalt composition shingle roof on this building was in poor condition at the time of the survey. The extreme temperature fluctuations throughout the year, consistent wind which blows sand and dirt on to the roof, and constant exposure to the sun are contributing factors to wear and deterioration. The roof has many patches on it and is a constant maintenance problem. It is recommended that this building be re-roofed in the next two to four years with a 50 year asphalt composition roofing shingle and new underlayments.

Administration / Housing / Culinary - Building #1388  
Description: Typical roof patch.

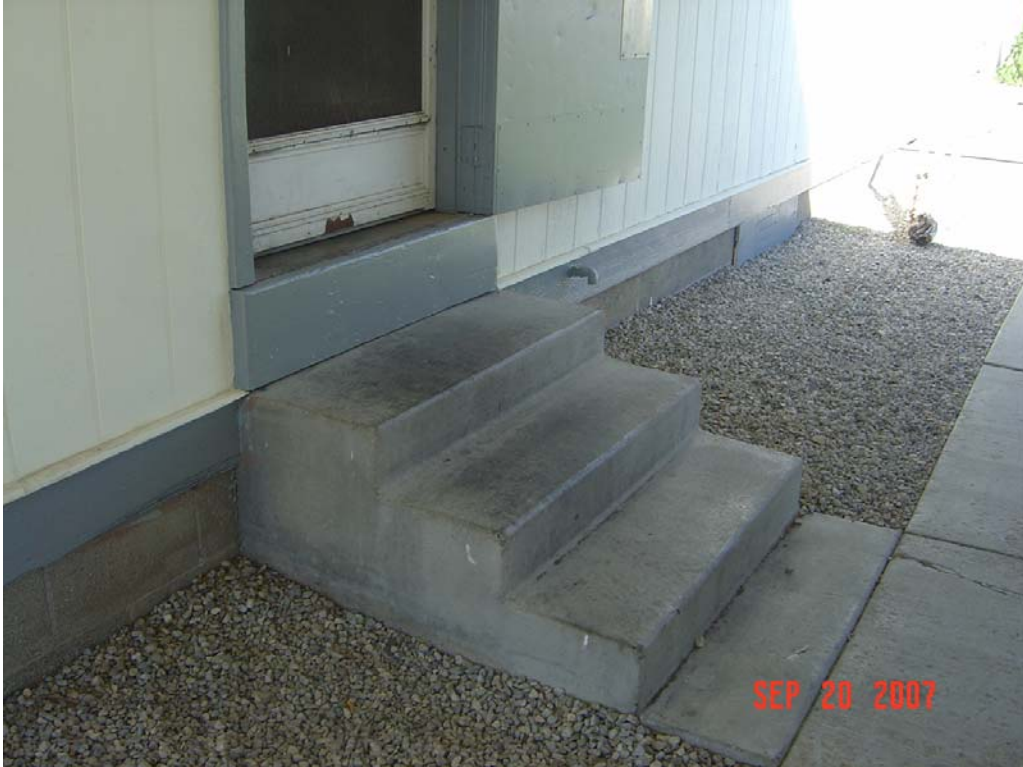
Administration / Housing / Culinary - Building #1388  
Description: Exit stairs lacking handrails.

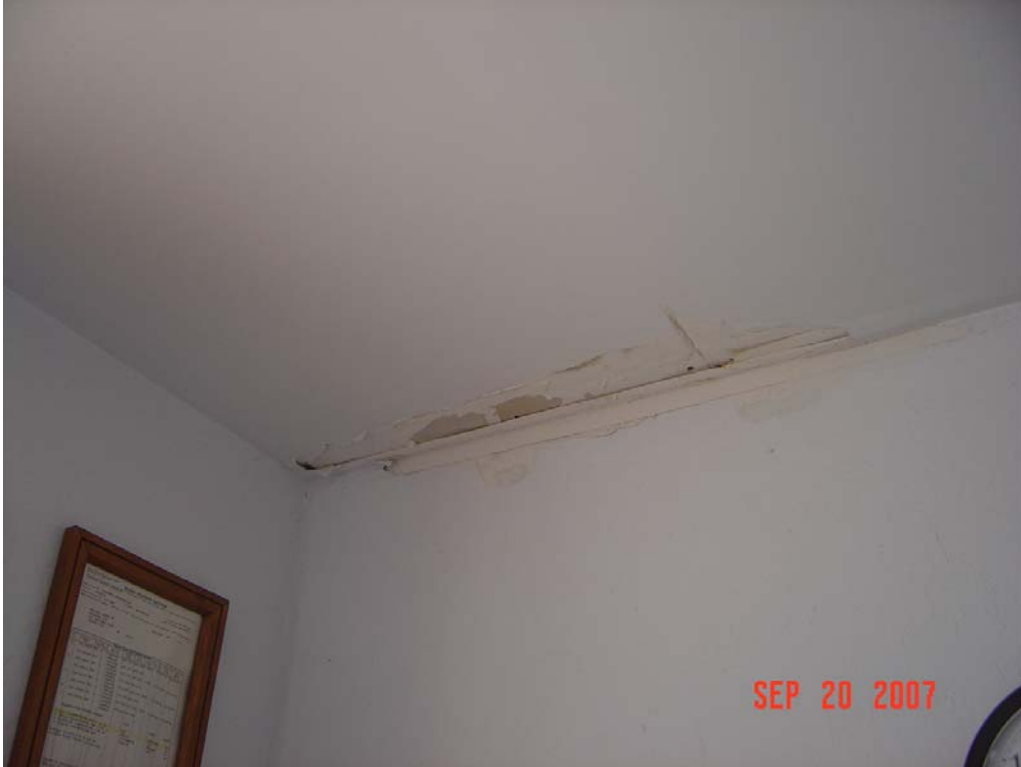
NDF Office - Building #0881  
Description: Water damaged ceiling.
